MZ TS125 Sport Diary – Started June 2018

This is one of the special edition TS125 Sport's that Wilf Green produced in the early 1980's, not sure how many were made but mine dates from October 1983. It came from my friend Andrew Long on a sort of sale or Return basis. Basically I can keep it and use it as long as I like but if I decide to part with it, Andrew has first chance. From the sparse information and pictures around it would seem they were only ever made with the red finish. This example is probably not completely original, all the others I have found and the brochure that was in the documentation pack show the headlamp and shrouds to be red – easily fixed as the tinware itself is correct. Fortunately, all the parts unique to this bike, tank, decals seat and rear mudguard are correct as they would be hen's teeth to find.

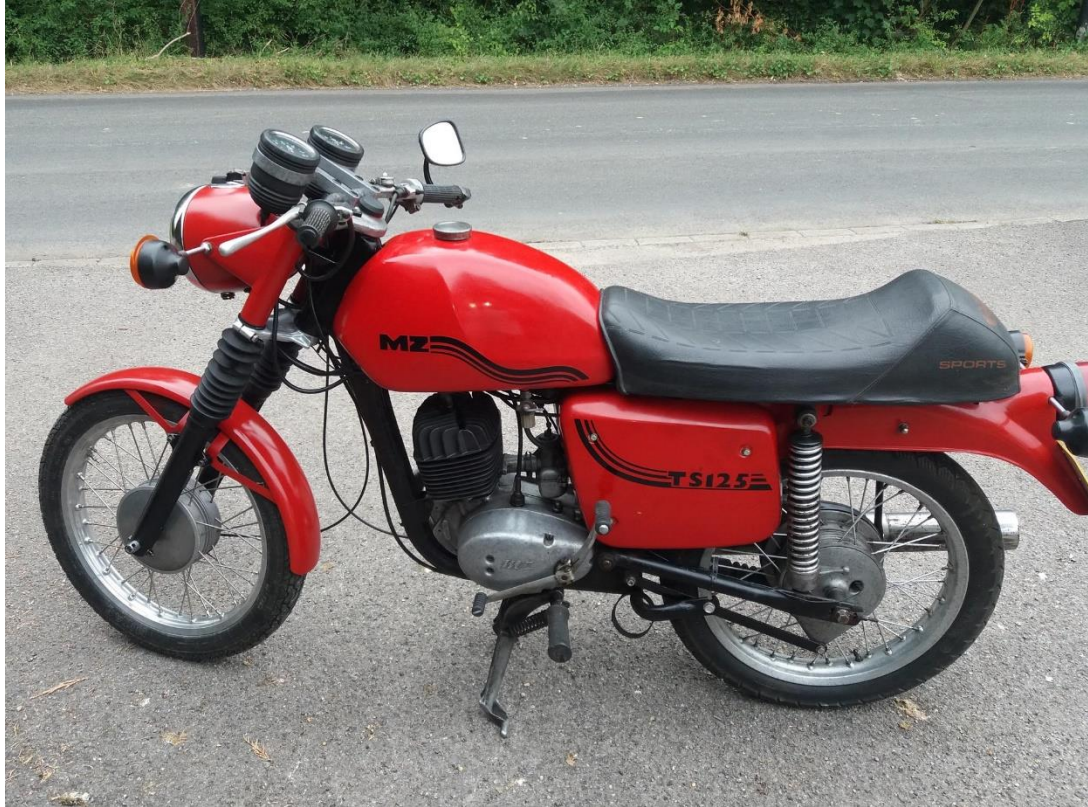
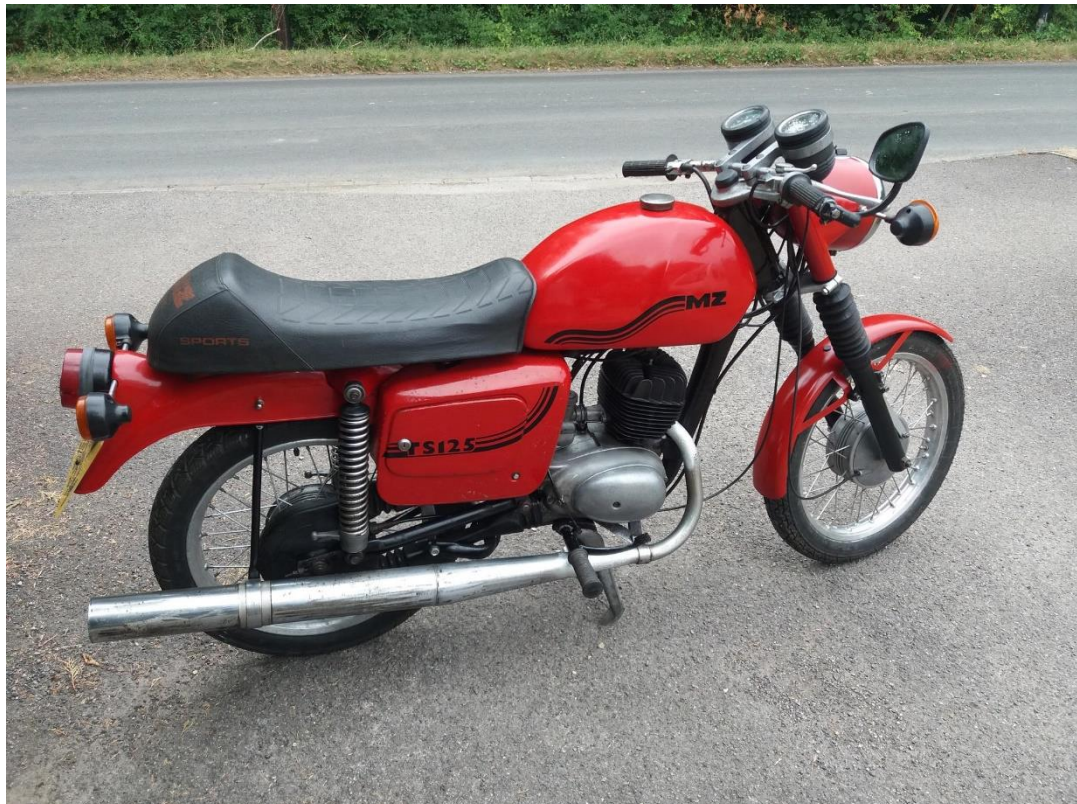
The repaint of the front end is now completed and some pictures are below. The shrouds, headlamp shell and the front mudguard have all been stripped to bare metal, primed and painted red. Whilst the bike was in the workshop, I also removed and straightened the right hand footrest bar and then stripped and repainted that black. Looks much better especially with a new footrest rubber. Had a bit of a problem with the wiring which refused to work at all initially. Eventually I traced the problem to a duff switch and once that was in place, all was well.

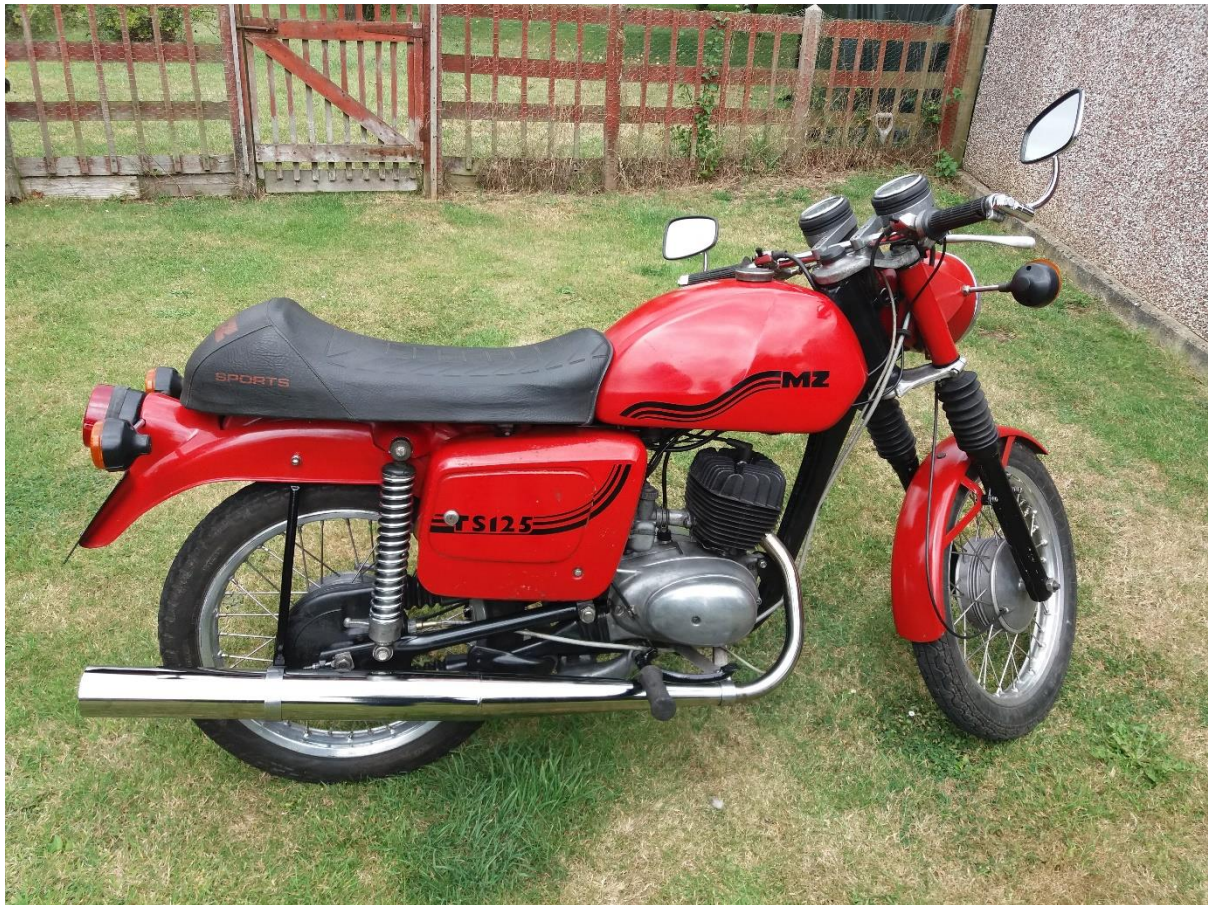
I also felt the bike was looking a bit tatty particularly the frame. So in August I stripped it down, had some parts powder coated and repainted the frame and swinging arm. I left the tank and sidepanels because they still have the original transfers and I have not managed to locate replacements. A new silencer was fitted along with new rear shock springs and a few s/s steel fasteners.

The result is shown in the picture below.

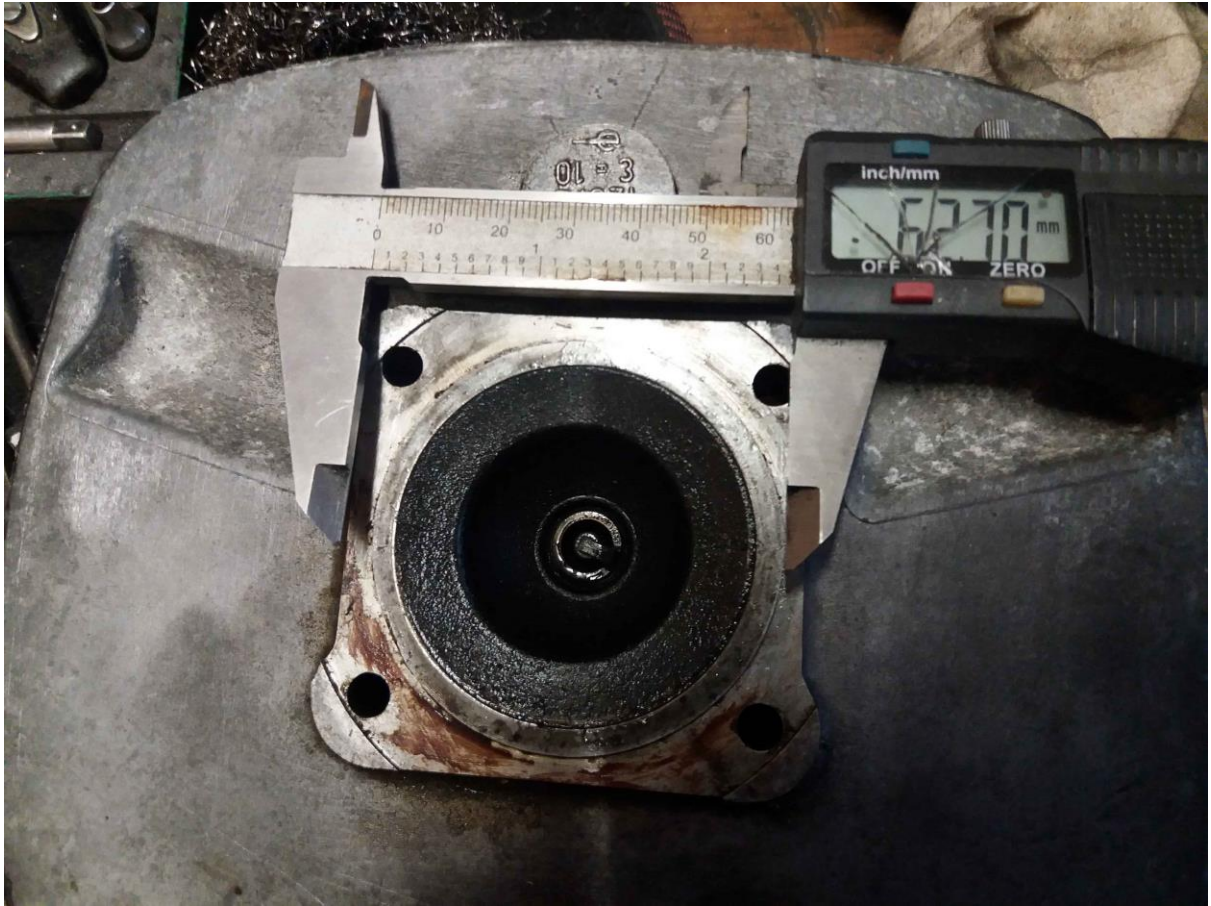
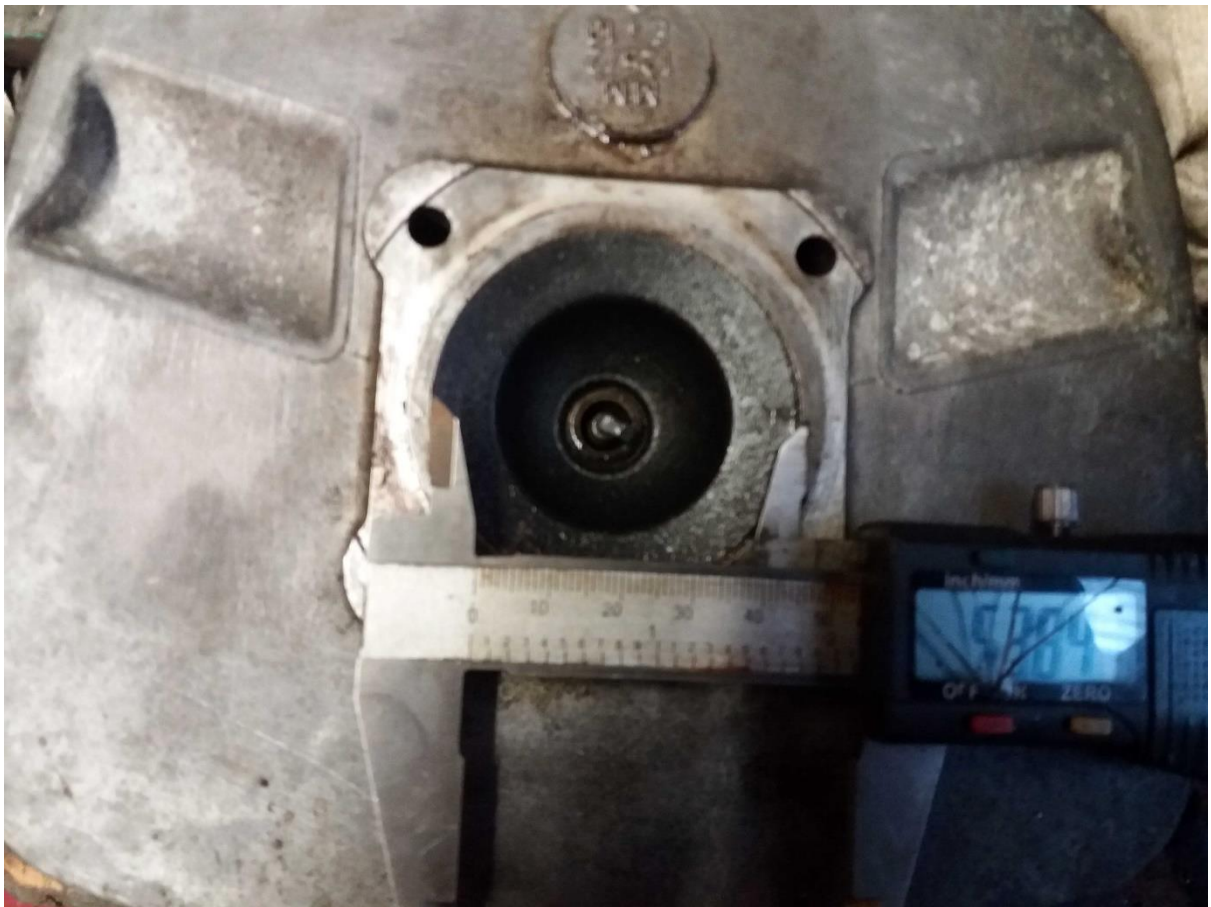
I had another look at the 125 cylinder head and took the photos below which show the sealing ring. It is 54mm internally and 63mm externally giving a surface width of 4.5mm. Does not seem much but it is clearly sufficient as I have not experienced and head joint leakage on any TS125/150 I have owned. There is no gasket, it's a metal-metal joint. However, with the barrel bored to 56mm the ring would only be 3.5mm wide. I imagine the 150 head has different dimensions – something I am hoping Andrew Long will be able to confirm. As an experiment I have made a head gasket with 56mm bore and 1mm thick. According to my calculations this will restore the correct cr using a 125 head but whether it will be strong enough is another matter. The engine does start easily and sounds fine so I may try it on my short test circuit which minimises the amount of pushing needed to get home if it does fail.

The top end was stripped today and it now has the 150cc barrel and piston fitted with no particular issues. I checked the big end which seems to be in excellent condition. Not so the little end which I have replaced with a new one I had in stock. However, I am unhappy about using the 125cc cylinder head as it would raise the cr sky high and I cannot see safe way to modify it as yet. I am consulting others about this and casting the net wider to try and source a correct head. I plan to run it with the 125 (15t) gearing and the 22mm carburettor during the running in period. Top speed was never the issue with this bike it was lack of power on hills. Both decisions can be reviewed later.
