Makeover for a 1970 BMW R75/5

The preamble – October/November 2012

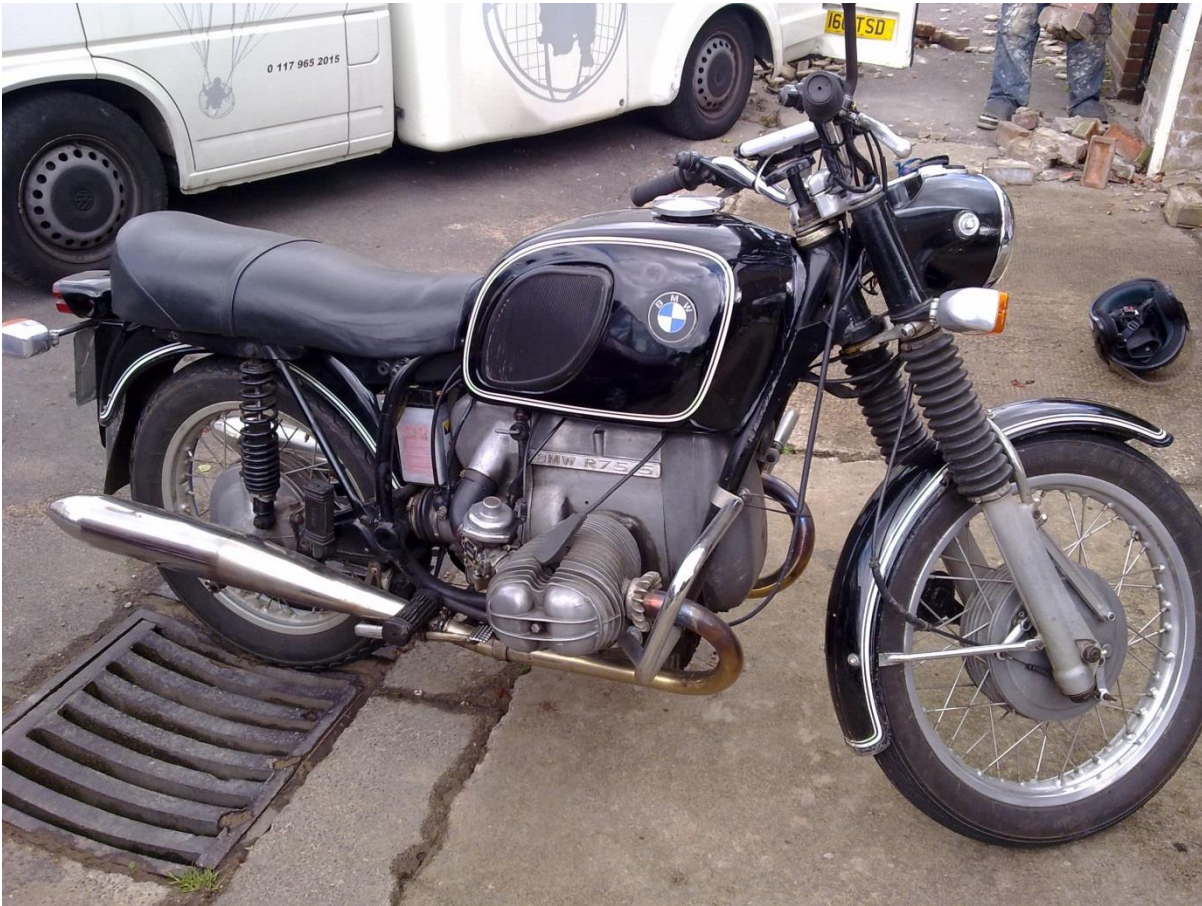
The R75/5 when bought in 2011 – Scruffier than the picture suggests

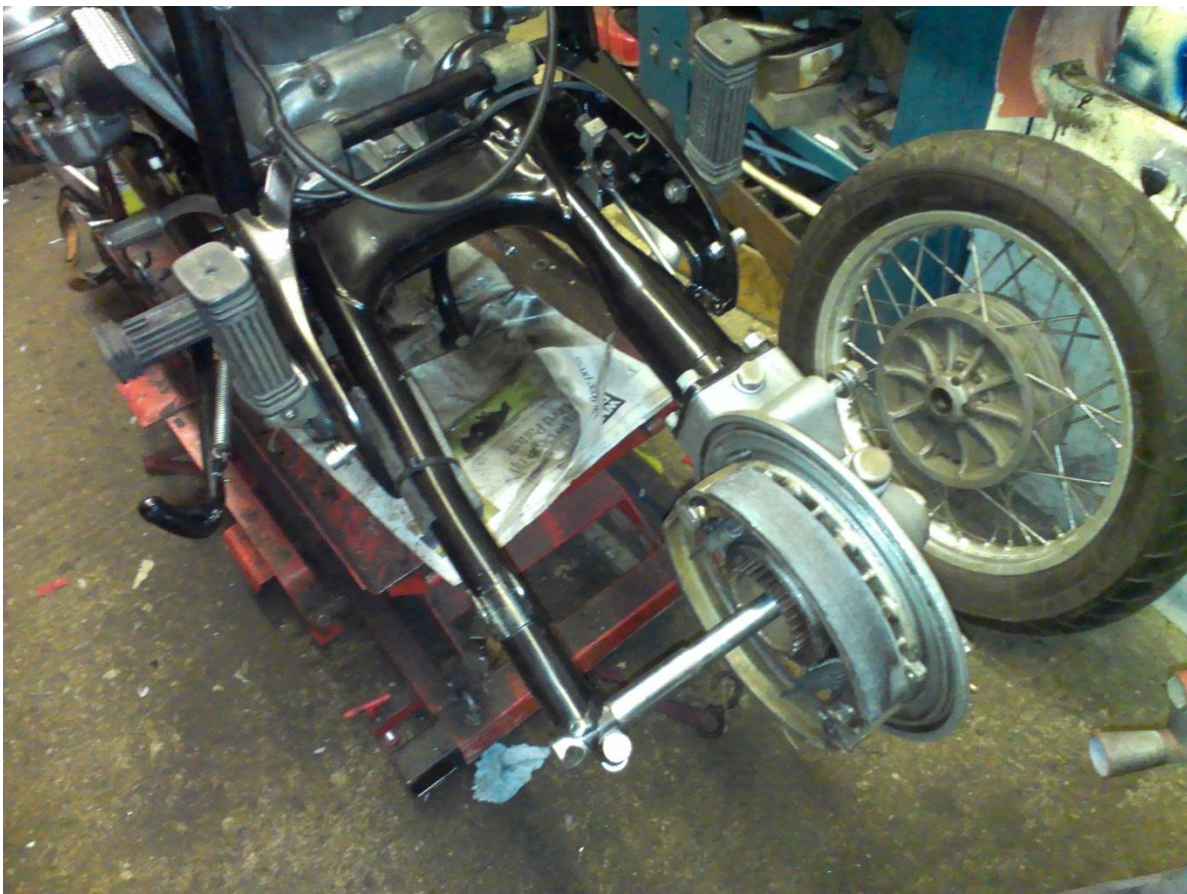
With the front end virtually complete, I was able to tackle the back end. First the LWB sub frame and rear mudguard were loosely fitted just to make sure it all went together properly; which fortunately it did. I was relieved to find that the original cables to the back end were still on enough otherwise I would have need to splice in extra pieces. On the original rear sub frame the cable runs though the top tube but the LWB sub frame has no such feature so the cable will have to run alongside the top tube. This may be why it is still long enough. The battery box was then offered up and proved to have totally different fitting. After some pondering I made up a pair of top mounts in very strong plastic which was heated and hammered to shape. The bottom sits on rubber tubing from a car top hose and "U" shaped metal brackets will be riveted to the base of the battery box to locate it on the rubber mounts. This combination should be strong enough and provide some insulation from vibration.

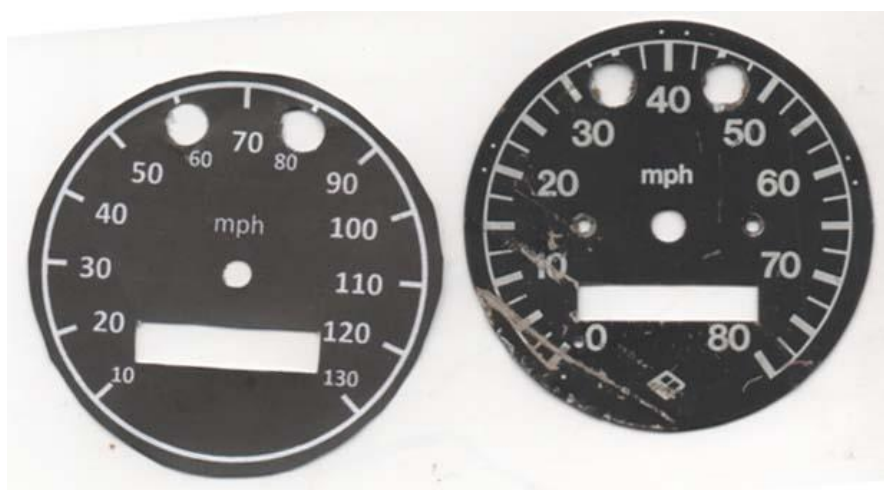
I have a cunning plan regarding the re-calibration of the MZ speedo. They are relatively easy to dismantle and I have an old broken one which has been stripped to gain access to the dial. Using this as a template I have made a new dial with revised settings; the pictures are shown below – original dial on the right:

At present I have no idea how accurate my new dial is but that is not critical for now. The important thing is that I have a template against which to mark up the settings once these are known. The new face will be laminated for strength and appearance and the white areas will be punched or cut out. In the case of the

rectangle to make the odometer visible. In the case of the circles to show the warning lights. The coloured lenses will push through the holes. This has all been done in trial mode. What I need to do once the bike is mobile again is some test runs using the bicycle speedo as a guide and a chinagraph pencil to mark the present speedo dial for various key speeds. I can then adjust my template; it will not be totally accurate but near enough. Of course the odometer will still be uncalibrated but so far I have no solution to that. Based on my previous experience of fitting an MZ speedo to a BMW R45, the speedo will under read so using an MZ speedo calibrated to kms will get the odometer closer to the truth. There is even a faint chance that a standard kms speedo will be close enough to use without my other mods. . Anyway it will be fun trying and I am now scanning Ebay for a kms speedo as a donor.

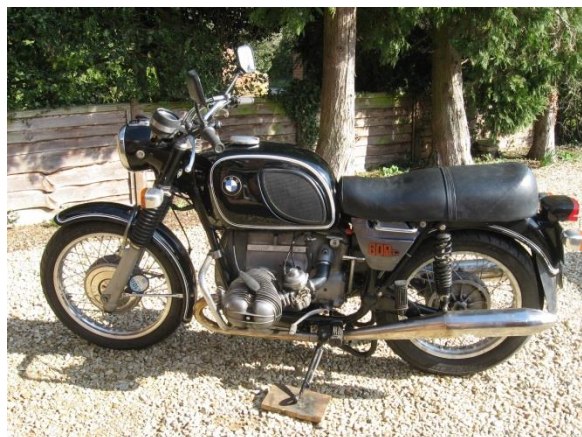
The MZ speedo worked but at 20mph on the bicycle speedo was only registering about 7-8mph. This was much lower than I expected so I did some test with a couple of other MZ speedos using my electric drill. I

found one with that produced around double the speed for the same input revs so this was fitted instead. By now it was dark so further testing will have to wait another day. Tomorrow rain and possibly snow is forecast so it might be a while. The only down side to this speedo swap is the colours of the warning lights. Neutral is now red and main been is green. I should be able to sort this out when I have re-calibrated the whole thing so will live with it for now. One other thing that was reassuring was the headlight alignment. I thought it might be too high even in its lowest position which can be comfortably achieved

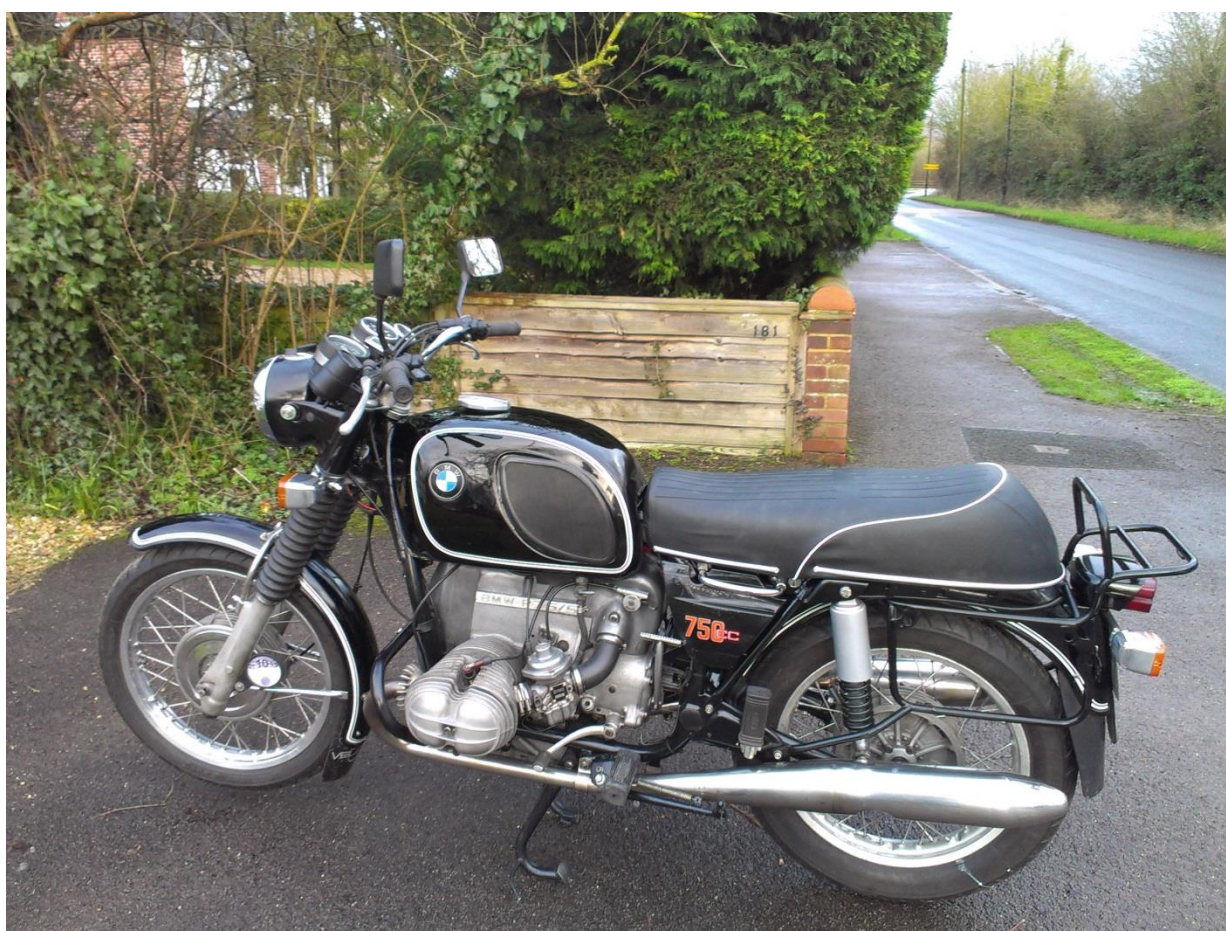
of the finished (well almost) product. The small picture is a reminder of what it looked like when I bought it. Not a huge difference in some respects but the original photo does mask a lot of detail faults. I am happy with the result anyway and it has turned out pretty much as I wanted. Just the speedo to sort out as far as I know; however, looking at the picture I can see the rear indicator is not quite aligned.
